**UNITED STATES ENVIRONMENTAL PROTECTION AGENCY
REGION V**

DATE: Request for Emergency Action at Summit National Site,
Deerfield, Ohio.

FROM: Grace Pinzon
Remedial Project Manager

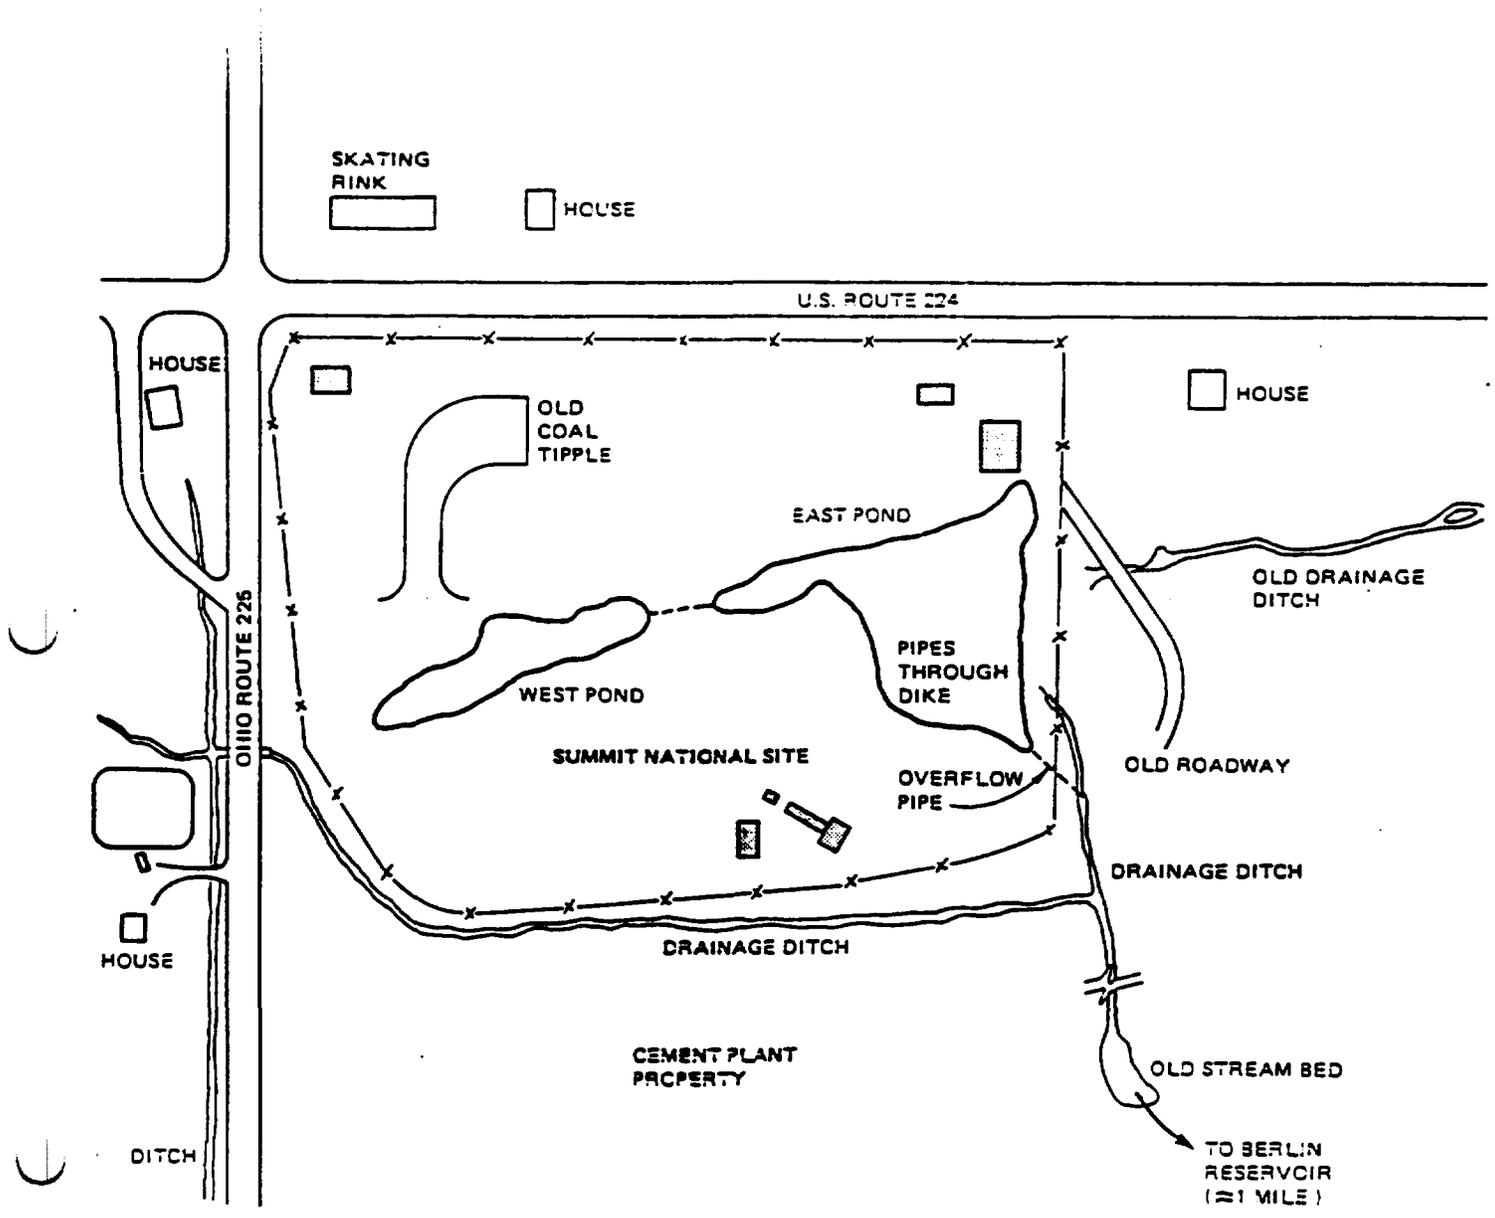
FIGURE 1 - SITE MAP
 SUMMIT NATIONAL SITE, OHIO

Other features on site include an abandoned incinerator and two abandoned buildings in the southeast corner, a scale house in the northwest corner and two dilapidated buildings in the northeast corner. (See Figure 1 Site Map).

There are three gate valves apparently designed to control pond elevation. However, these valves were closed, causing the pond to overflow. If the valves were opened, the water would discharge to the impoundment located approximately 300 yards downstream.

receives the discharge of a French Drain which was installed around the perimeter of the facility. The French drain which was part of Ohio EPA's stabilization action. Three submerged overflow pipes were designed to allow the east pond to discharge into the drainage ditch which flows southeast to the neighborhood. The valves and pipes are not functioning, thus flooding the east portion of the site.

The embankment of the east pond should be restored and elevated to allow additional storage capacity. If the valves and pipes are not operable, then a relief system should be installed. Ohio EPA will not allow any discharge of untreated water, therefore, it will be necessary to provide some type of treatment to the effluent.

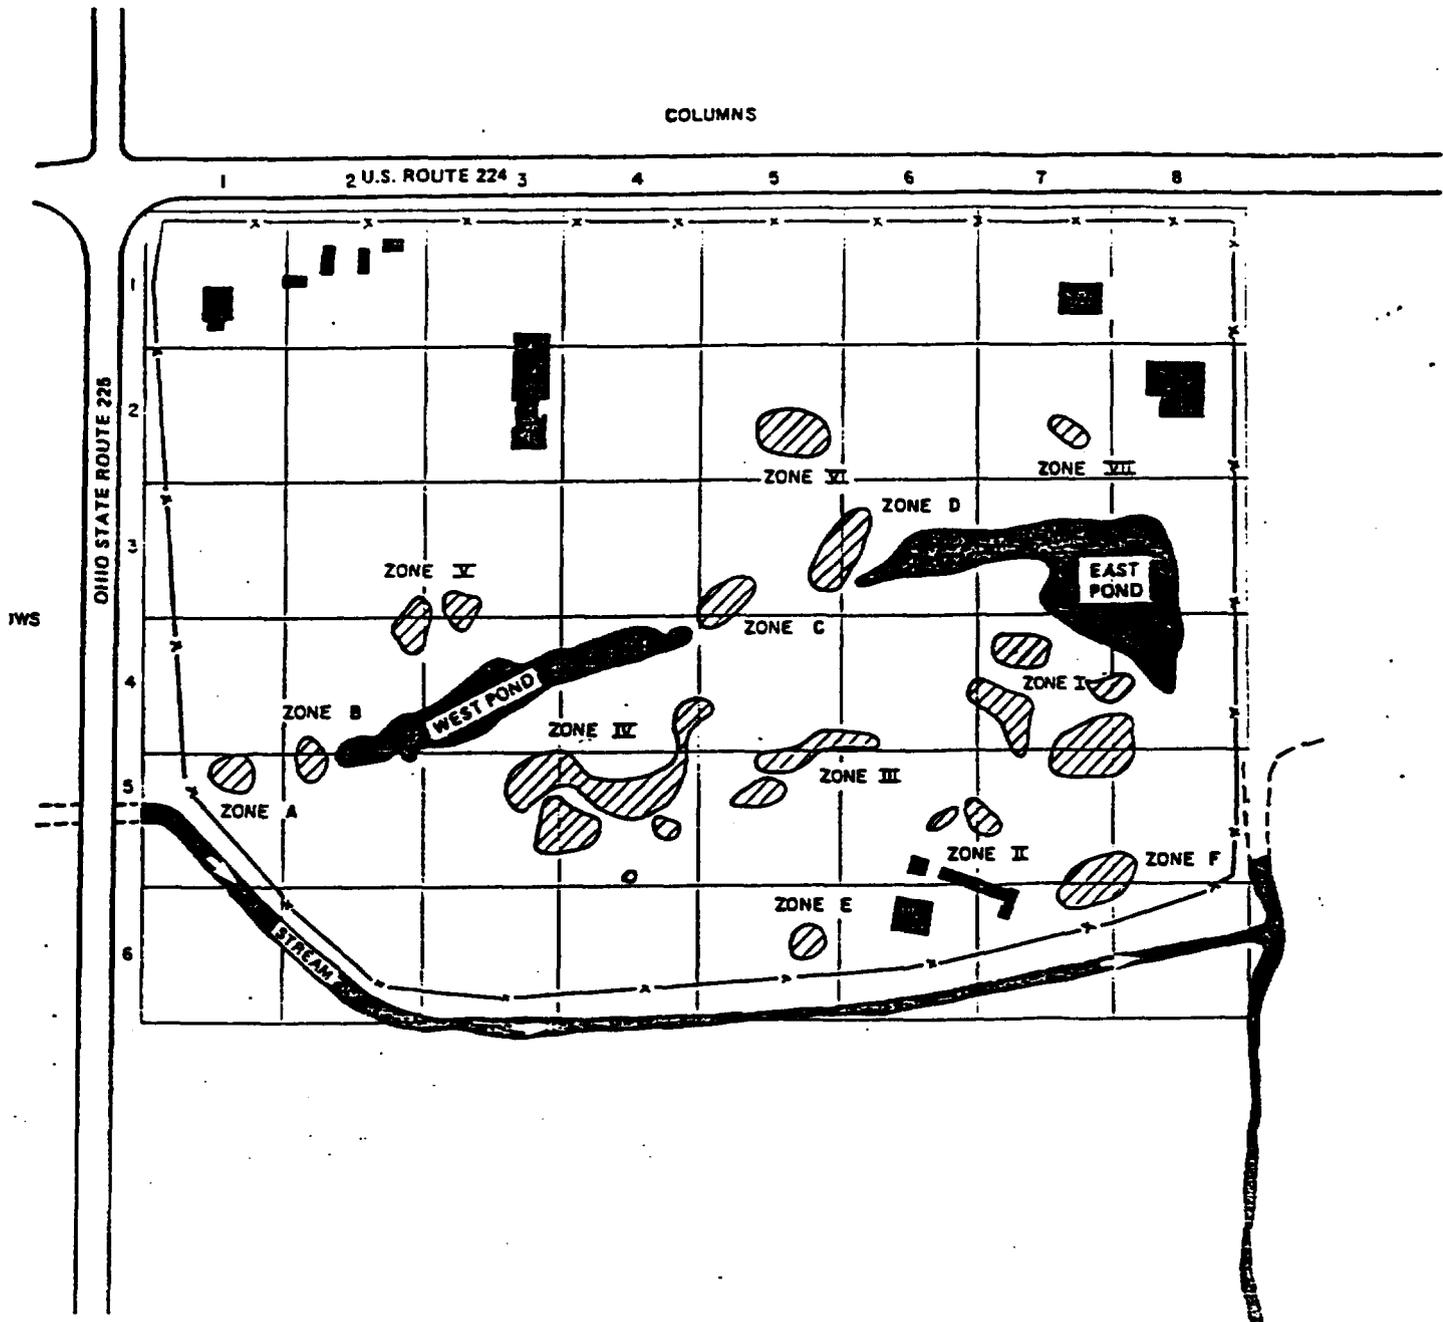
FIGURE 2 - POTENTIAL DRUM
BURIAL LOCATIONS

Thirteen areas of suspected buried drums were identified during the RI activity. Three of the suspected areas are located in the northeast portion of the site which falls within the flooded area. Other zones of suspected buried drums are located immediately south of the pond. (See Figure 2-Buried Drum Locations) If the area continues to flood, the increasing hydraulic pressure and low cohesion of the soil will facilitate the displacement of the drums and their contents. In addition, the water will percolate through the soil and eventually come in contact with the drums, thus contaminating the groundwater.

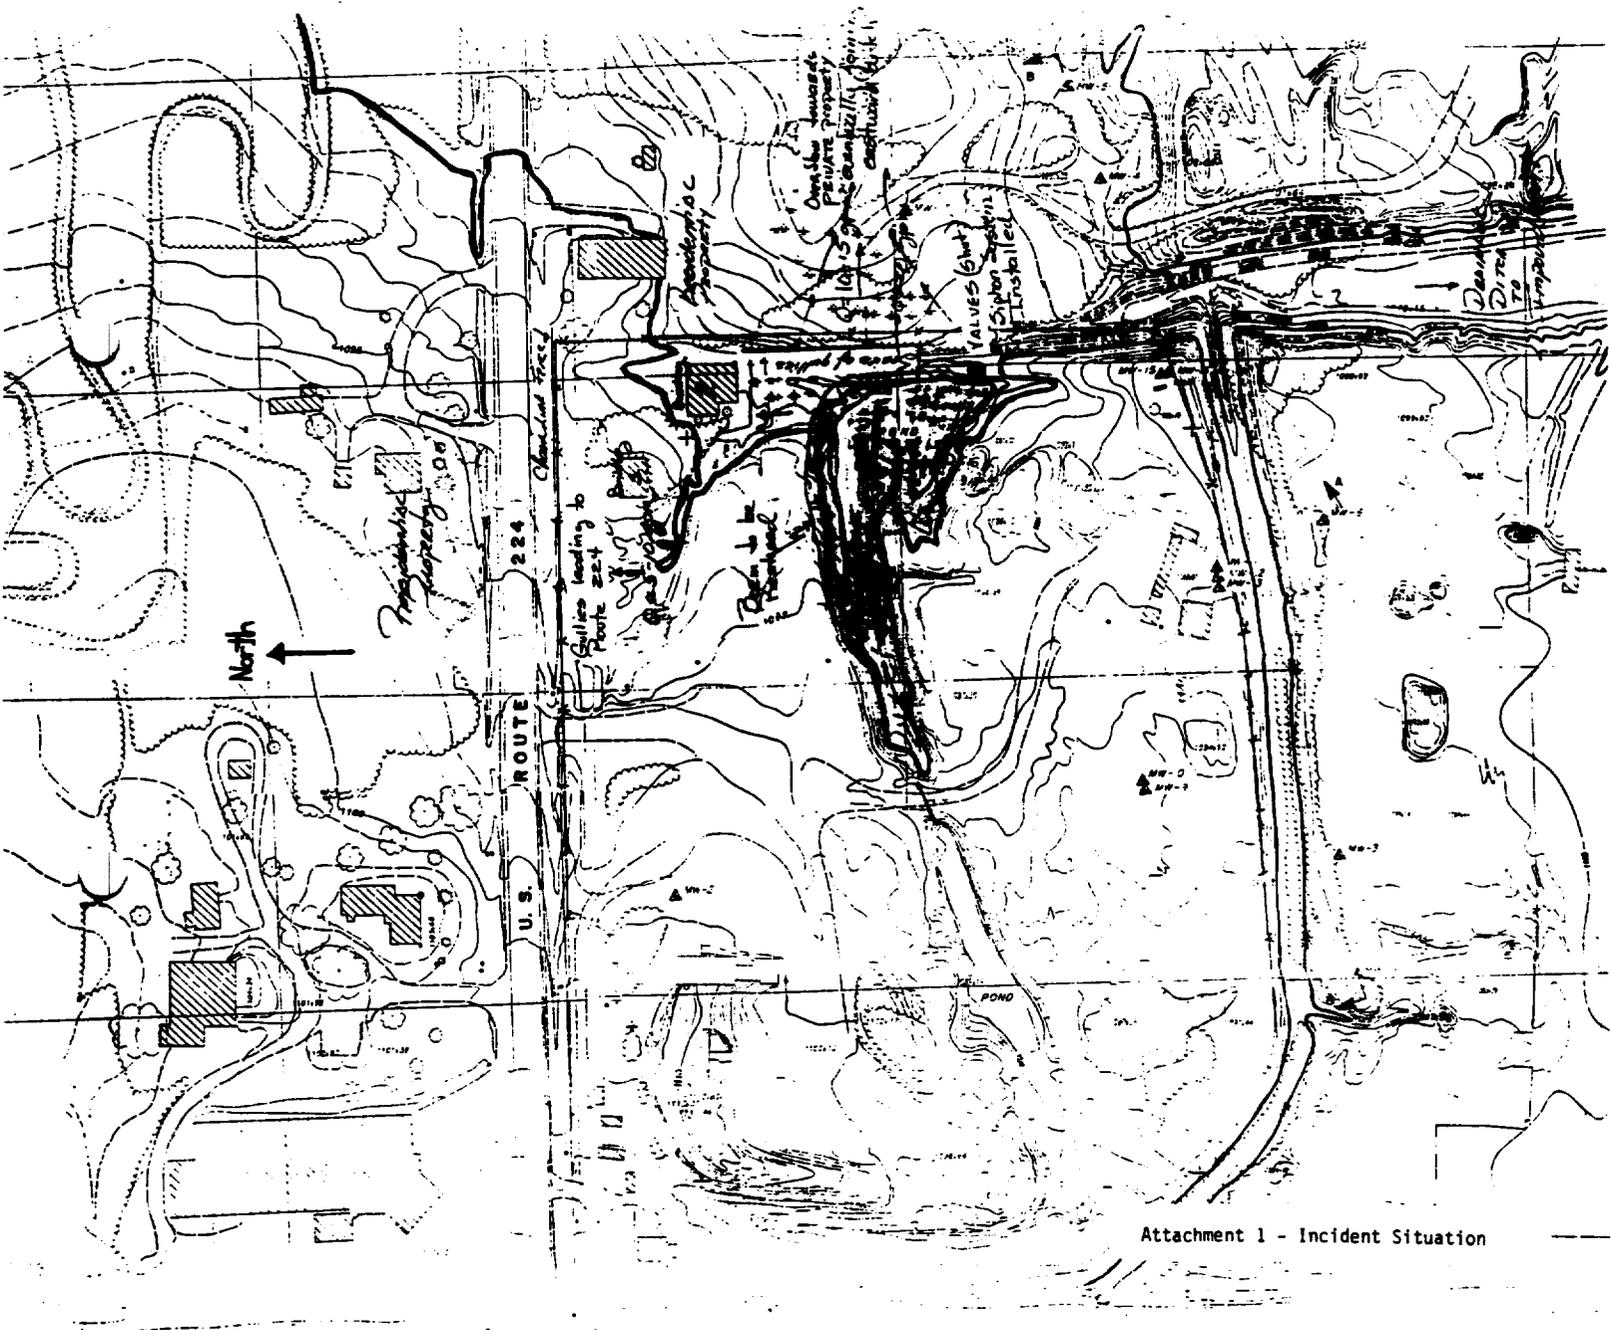
Attachment 1 - Incident Situation

Initially the water was flowing over the east portion of the site moving off-site towards private property, approximately at an elevation of 1089. (Refer to Attachment No. 2) A series of gullies align the east perimeter of the site to a distance of approximately 100 feet from building #2. The water level in building #2 is very high. The average flow rate in the gullies ranged between 10 and 20 gallons per minute.

The northeast portion of the site has gullies that lead very close to U.S. Route 224. The average flow rate ranged between 5 and 10 gallons per minute.
